# **Technical Report**

Report No R17084

**Product Tested:** Traditional Sliding Sash Window

Standard Specified: PAS 24:2016 – Enhanced security performance requirements for

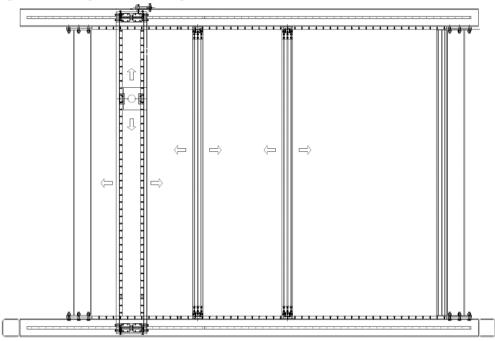
Figure 1 – Test rig used for testing

The test sample was supplied mounted in  $100 \times 50$  mm timber sub-frame in accordance with manufacturer's installation requirements. It was fitted into the test rig, shown below which was constructed to meet the requirements of the test specification and was fitted plumb, square and without twist or bends.
